**HAI TISEEN PRIMARY HEALTHCARE CENTER  
TAMEEM PROVINCE, IRAQ**

**SUSTAINMENT ASSESSMENT**

**SIGIR PA-08-158  
APRIL 16, 2009**

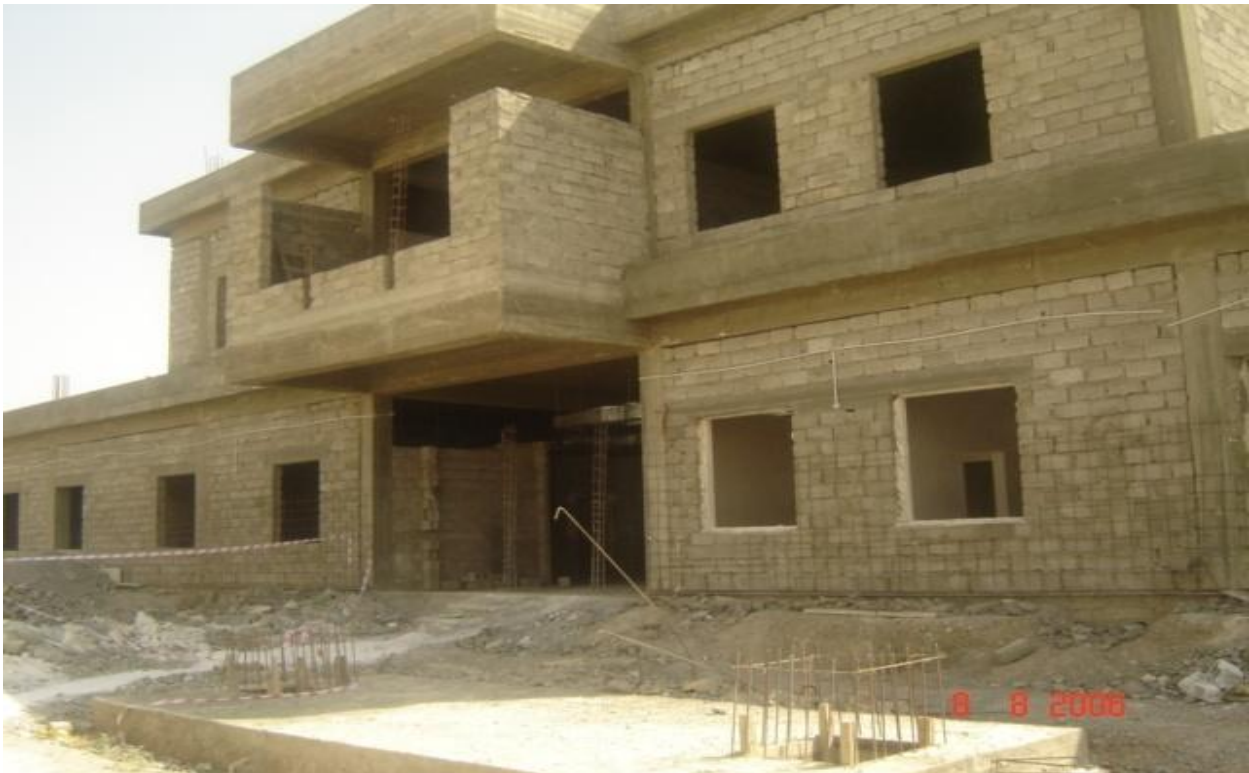
**Site Photo 1. Condition of partially constructed PHC when the new contract was awarded  
(Courtesy of GRN)**

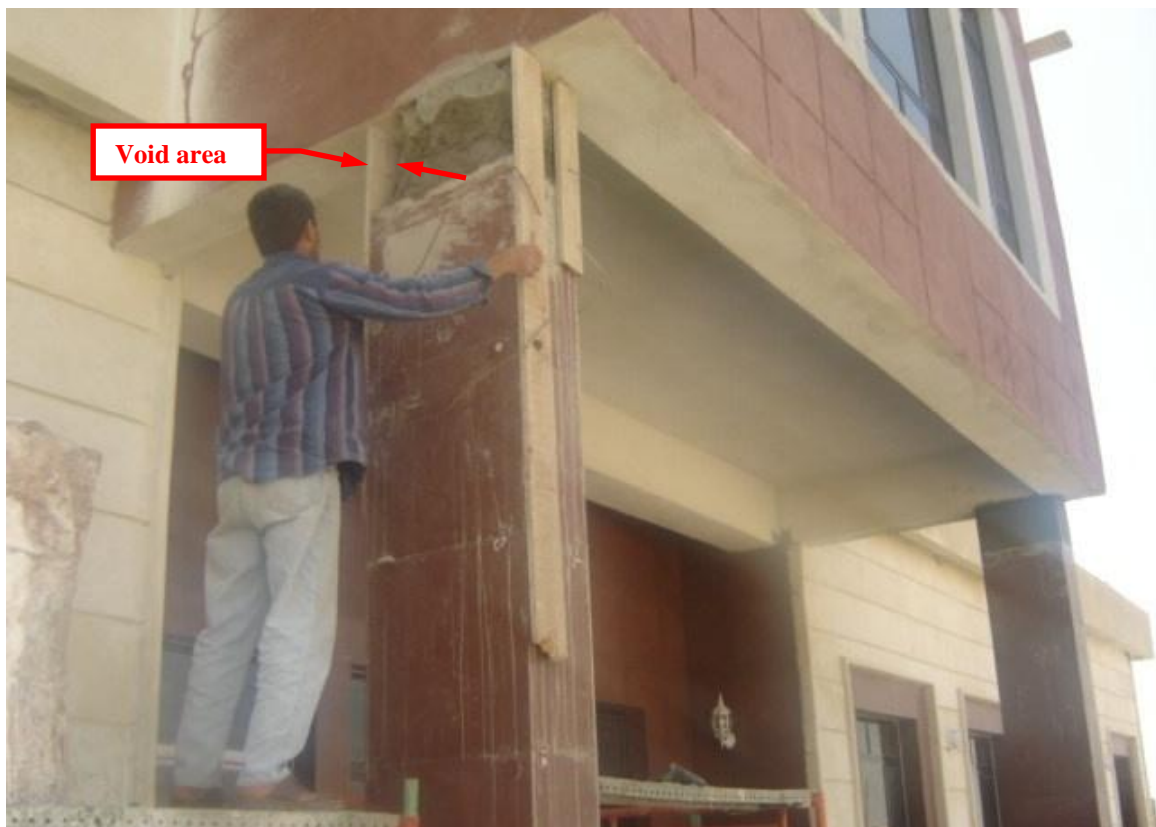
A review of the QA reports and photographs identified an issue with the quality of the connection between the newly constructed column and the original structure. Site Photo 2 shows the exposed connection prior to placement of the finish tile. The column contact area at the connection appears to be significantly less than the cross sectional area of the column. The void area at the connection is also asymmetric and may induce off-center loading of the column that was not anticipated in the design.

**Site Photo 2. Apparent poor quality of beam/column connection  
(Courtesy of GRN)**

The poor quality concrete and the reinforcing steel splice would result in a connection with very little shear capacity. This would severely limit the amount of lateral load transfer at the connection and could result in complete failure of the connection under a lateral load caused by wind or seismic activity.

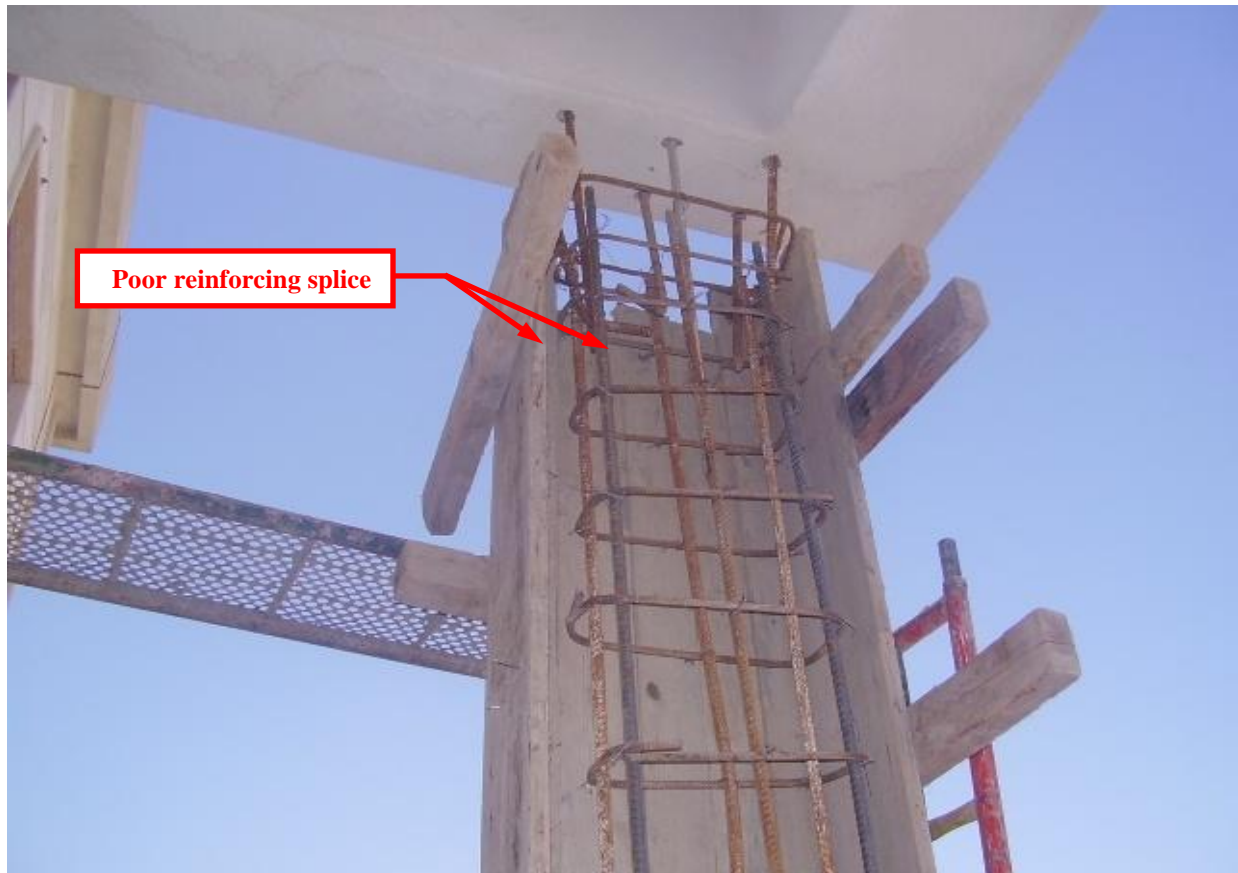
In addition to the poor quality concrete work, the QA representative identified an issue with the reinforcing steel splice. The QA report, dated 7 March 2007, identified Site Photo 3 as “*over lap is not good.*” After reviewing the photograph, SIGIR agreed with this assessment.

**Site Photo 3. Poor quality reinforcing splice (Courtesy of GRN)**

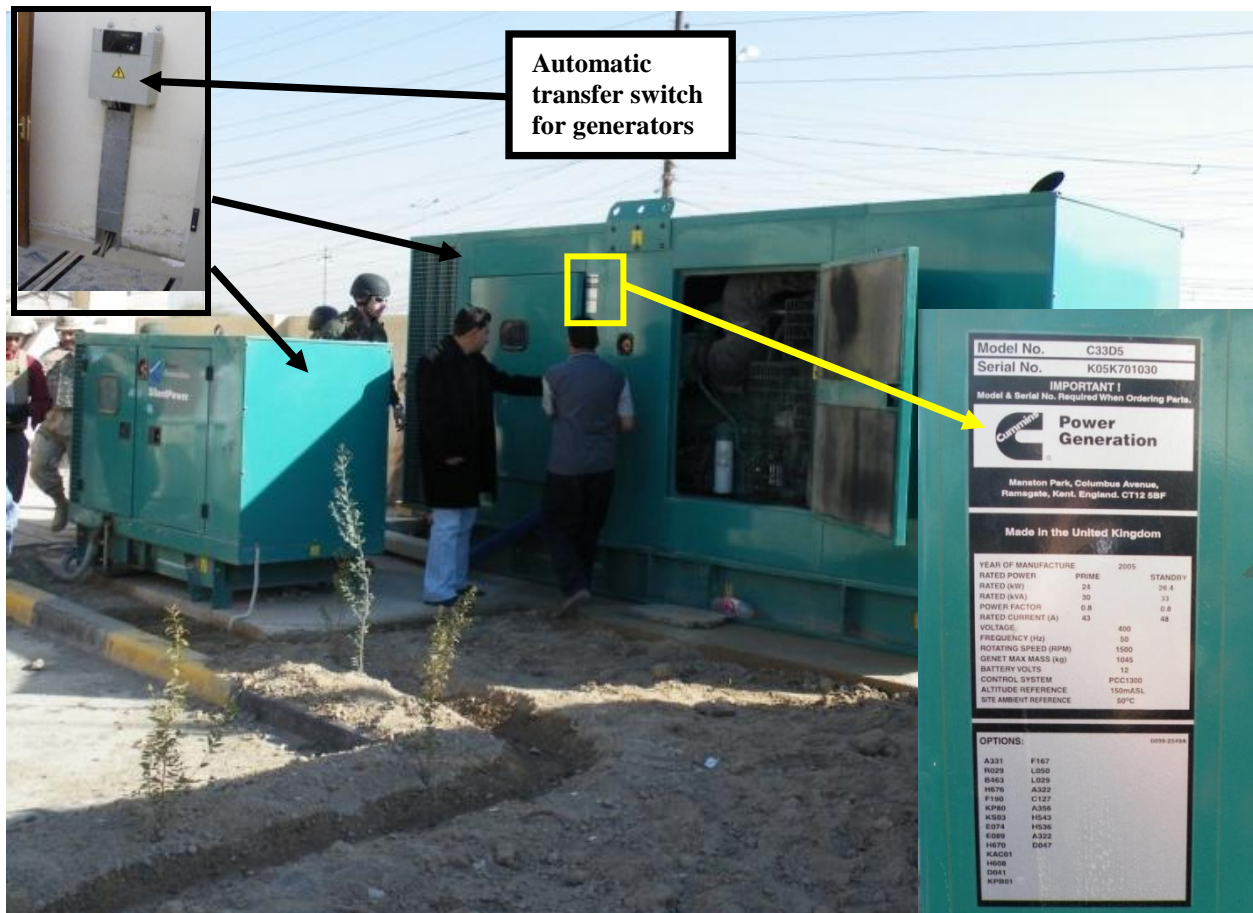
Since the Hai Tiseen PHC is connected to national grid power, an automatic transfer switch is critical to transfer to generator power once electricity from the national grid is lost. The PHC design incorporated the use of an automatic transfer switch. SIGIR verified the installation of the automatic transfer switch, which according to the administrator, was functioning correctly.

Site Photo 5. Two generators providing primary and emergency backup power for the PHC

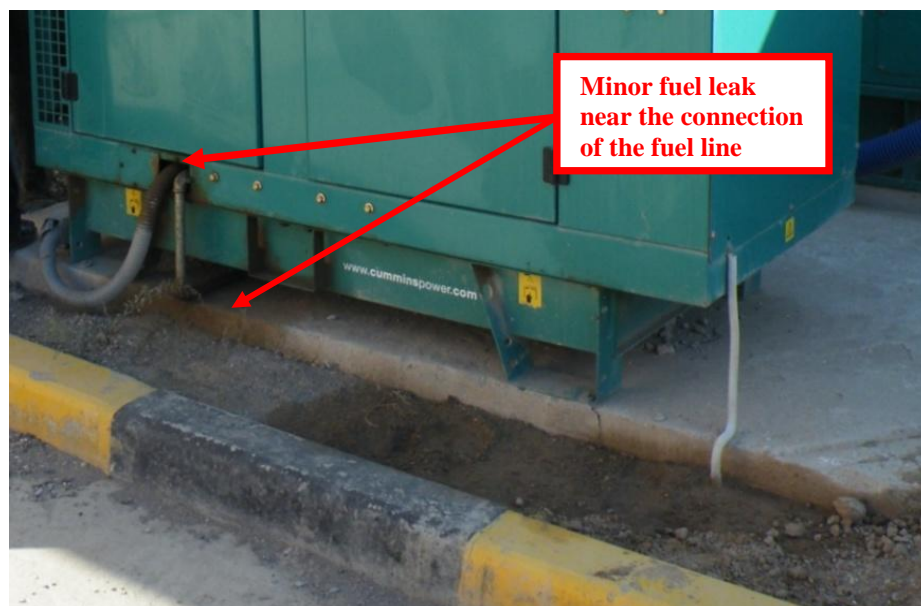
SIGIR noticed evidence of a minor fuel leak from the 500-kV emergency backup generator (Site Photo 6). The minor fuel leak was near the connection of the fuel line to the emergency generator and had spread into the soil in front of the generator. This leak presents a potential fire hazard and the PHC's maintenance staff needs to investigate the cause and repair the problem.

Site Photo 6. Minor fuel leak from 500-kV emergency backup generator

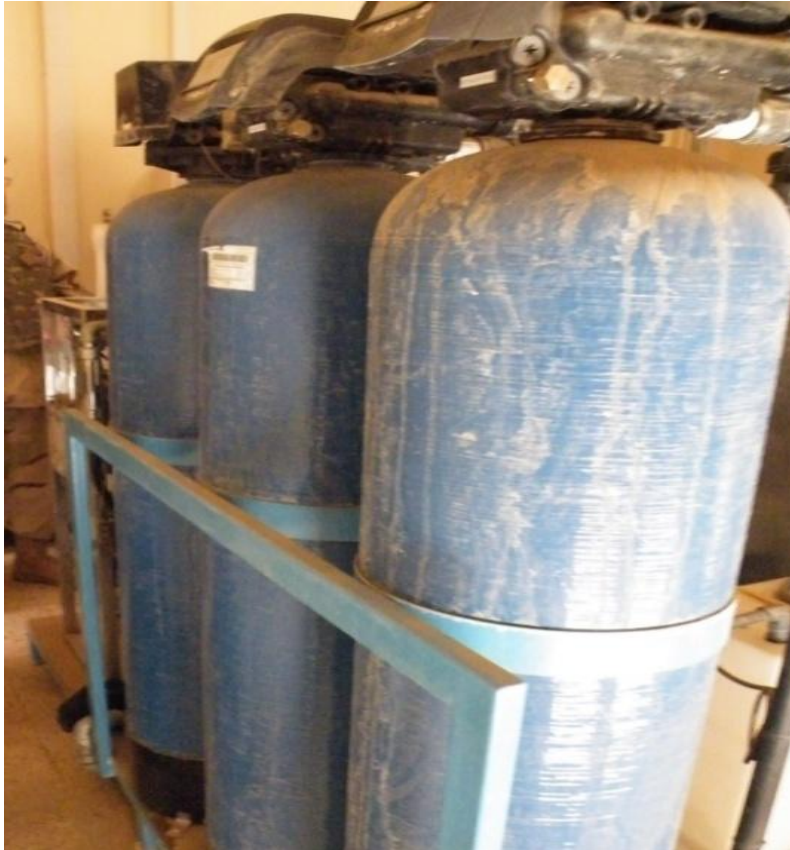
The RO unit appeared to be installed correctly and the administrator stated that the RO unit was functioning properly (Site Photo 7). According to the administrator, a part in the RO unit had failed initially; however, the PHC facility staff dismantled and repaired the RO unit.

**Site Photo 7. Functioning RO unit**

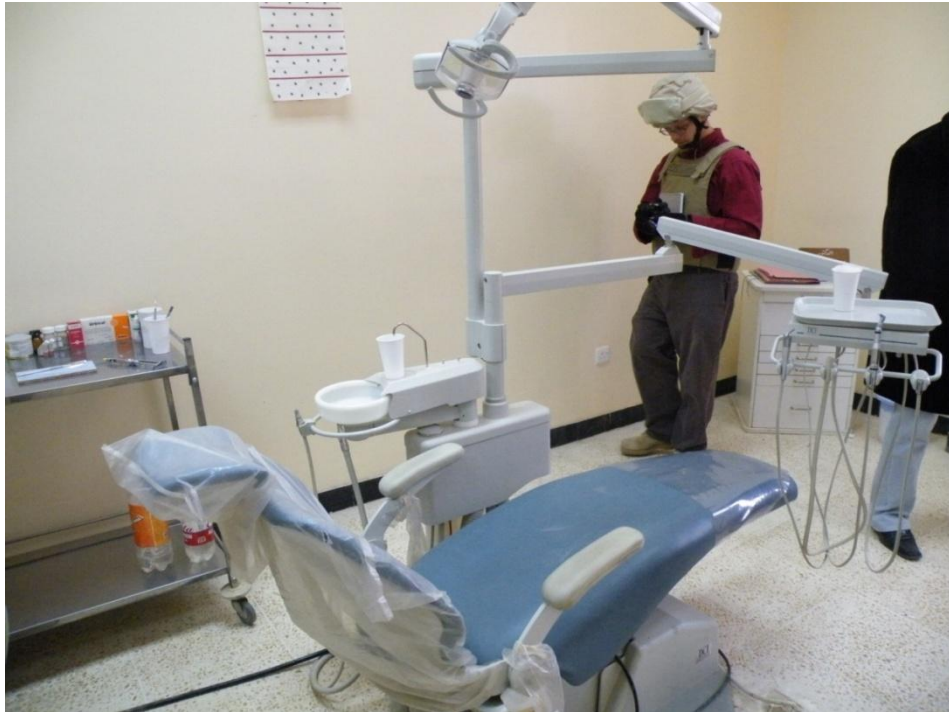
During the site visit, SIGIR observed that the dental chairs were installed. While one dental chair appeared to be in use (Site Photo 8), the second dental chair appeared to have a plugged drain with stagnant water in the rinse basin (Site Photo 9). During the inspection, SIGIR observed a dentist treating a patient while using the working dental chair.

The contractor's installation of the dental chairs, while functional, did not appear to conform to any known plumbing or electric code. The drain for each chair was placed directly into the floor drain with a significant gap between the floor drainpipe and the chair discharge hose. Also, the air lines were not connected for the dental chairs.

**Site Photo 8. Dental chair and tools**

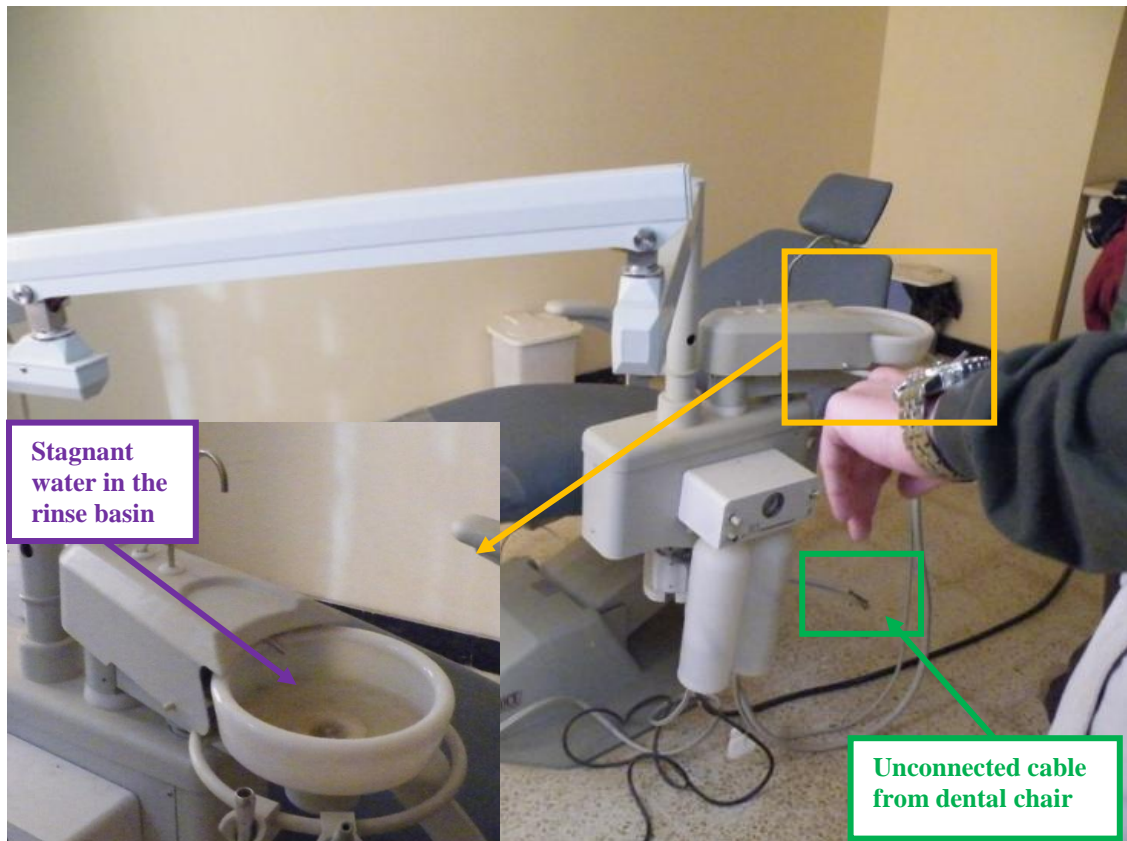
**Site Photo 9. Second dental chair with stagnant water**

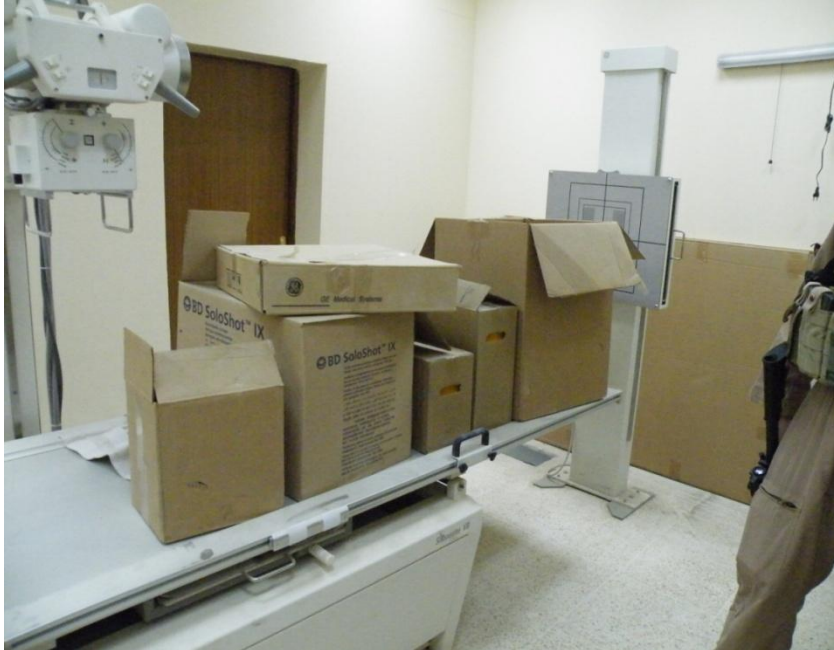
The PHC contract included medical imaging capabilities, specifically an x-ray room and equipment. SIGIR observed that the x-ray equipment was installed (Site Photo 10); however, according to the administrator, the contractor did not verify the equipment was operational. In addition, the administrator stated the facility's staff did not have the technical capability to operate the x-ray equipment; consequently, the facility cannot offer any x-ray services to its patients. Currently, the PHC uses the x-ray room as a medical supply storage room.

**Site Photo 10. X-ray room used as a medical supply storage room**

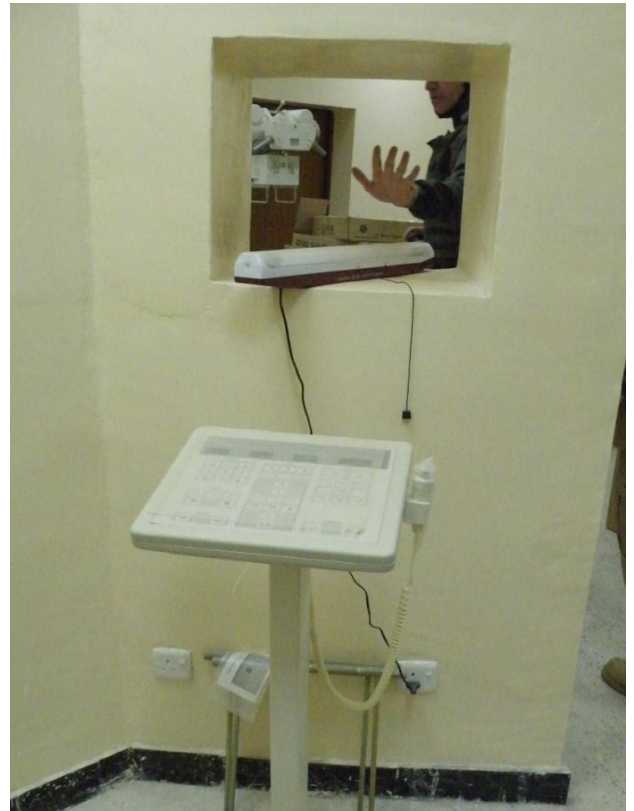
In the 18 July 2007 acceptance letter, one of the noted deficiencies was "x-ray machine," which was to be "installed later." SIGIR noted that the contractor did install the x-ray machine; however, the contract-required installation of a leaded-glass observation window was not installed nor was it noted as a deficiency on the acceptance letter (Site Photo 11). In addition, SIGIR noticed that the contractor installed x-ray room exterior door and darkroom doors appeared to be standard wooden doors. The inspection team could not verify the presence of lead lining on the concrete walls.

**Site Photo 11. Missing leaded glass observation window**
